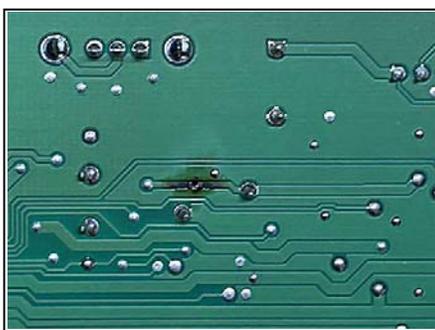
The fried circuit trace

The root cause turned out to be a short circuit between traces less than 20 thousands of an inch apart of what is in effect a computer circuit board. The short had blown the smaller amperage fuse but sadly, once the 15 Amp fuse was installed there was a cascading failure of semiconductors upstream of the short circuit. By the way, no blaming Lucas here, the instrument cluster was made by the French company Valeo.

Why would a circuit board that operated faultlessly for 18 years suddenly develop a short-circuit? One explanation could be "dendrite growth". I've experienced a similar phenomenon with our oven where I happen to learned that dendrite growth problems were tracked down to contamination of the Chinese manufactured circuit board when they were washed in impure water. I don't know if Valeo had its circuit boards assembled in China, but there's a good chance they did. If the pollutants are there, then in the presence of moisture, dendrite growth can occur in seconds. Perhaps, being a humid day, the instrument cluster of the car was cooled by the nearby A/C ducts and water vapor condensed on the circuit board soon after the car was powered down and there wasn't time for it to evaporate before I tried to restart it.

unidentifiable fried semiconductors, several failed attempts and 3-weeks of frustration, I finally managed to repair the board. However, the point of this entire article is that had I not been able to – and without some lucky guessing I wouldn't have – the next journey the car would take would be to the scrap yard.

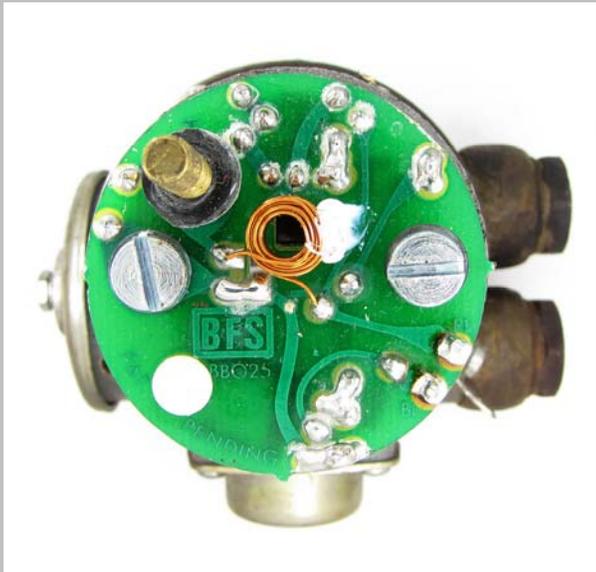
I've seen dendrite growth on MGs too, not on original equipment but on replacement electronic SU fuel pumps. In the case shown here it's unforgivable. Given the environment in which many of their pumps can be expected to operate, SU could have done much more to ensure board cleanliness and could also have applied a conformal sealing coating over the circuit board to keep out moisture. I hope that they too have now identified the problem and taken action to prevent it.

All the white areas around the solder connections are due ionic residues and those at the bottom of the board have actually joined together, which is why it failed and I was asked if I could repair it. Fortunately I could, as well as cleaning and sealing it to prevent further failures.
