The Story of a Poor Sucker

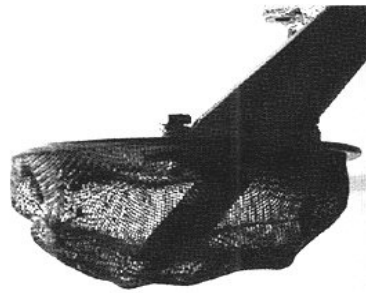
It was decided to remove the oil pan and it was reported that this almost sprang from the block when the last bolt was removed. The cause of the problem then became obvious. Someone at sometime had jacked the car up under the oil pan, bending and denting it so that it pressed up against the oil pick-up tube, crushing the strainer and severely restricting the flow. A few blows with a mallet and reinstallation of the oil pan was all that was needed to achieve normal oil pressure.

The angled pick-up tube can be seen inside the crushed
