The Ignoble Fuse Holder

by Rick Astley

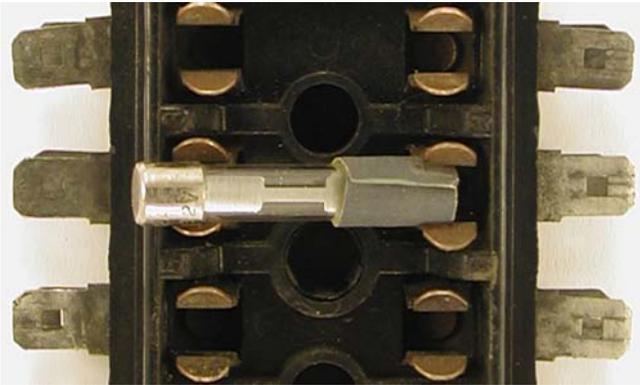
I have recently seen a rash of failures concerning the fuse holders on MGBs, but the problem could potentially occur on any MG. It exhibits itself as being the symptom of a blown fuse, but when the driver checks the suspect fuse, it turns out to be intact, yet current is not getting from one side to the other.

The reason the inside of the clip is building up a thin oxide layer is all to do with nobility. Yes, class comes into everything and metals certainly have class, or as it's called in the world of metallurgy: nobility. As you may guess, the noblest are the

The clips that retain the fuses in a Lucas fuse holder are made of a copper alloy, probably beryllium copper, copper being highly electrically conductive and beryllium imparting some springiness. Both copper and beryllium are relatively ignoble. The original glass fuses used in MGs, which I believe may still be available, had copper end caps. As the copper fuse end caps and their retaining clips were not made of dissimilar metals, corrosion was negligible to nil. However, look at the glass fuses in your MG and you'll likely find that unlike the original fuses, they have bright and shiny nickel plated end caps. Nickel is relatively noble and corrosion will occur when they are in contact with the inside surface of the copper alloy fuse clip, and because the clip material is the less noble, it oxidizes (a fancy word for corrodes) in the area in contact with the fuse cap, while the cap itself remains nice and shiny. Copper oxide (verdigris), while it does prevent electrical conduction is obviously a lot less destructive than iron oxide (rust).

The solution is usually (but see below) to take some fine sandpaper, grit side out, wrap it around the end cap of a fuse, insert the wrapped end of the fuse into each of the fuse clips one by one and move it around to clean the inside surface of the clip. The effect is to remove a very thin layer of electrically insulating oxide from the inside of the clip that prevents current flowing to and from the clip and the fuse cap. But why is the problem occurring?

- Acquire and install original style copper ended fuses
- Use sandpaper to clean the inside of the clips at the beginning of each driving season.
- Install a modern fuse block, itself with nickel clips. However, finding one of suitable size with double contacts at each end may be a challenge.

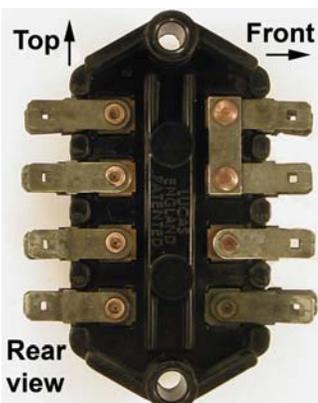
There is another less common failure of the fuse holder and that is loosening of the rivets that hold the terminals, the plastic body and the clip together. If it is easy to 'wiggle' the terminal relative to the fuse block plastic housing, then it may be necessary to tighten the rivet. Care must be taken in doing this as the plastic used is not as resilient as that found today and it will have become even more brittle over time. Using a rod, such as a nail-set punch, working from the underside, support the top side of the rivet, which can be seen at the bottom of the fuse clip, and gently tap the bottom side, again using a suitable punch. Note the bar joining the left and right side-lamp fuses. Make sure that the block is reinstalled correctly with the bar toward the front and top of the car.
