MGA 3 point seat belt upper mount option

By Ralph Poupard

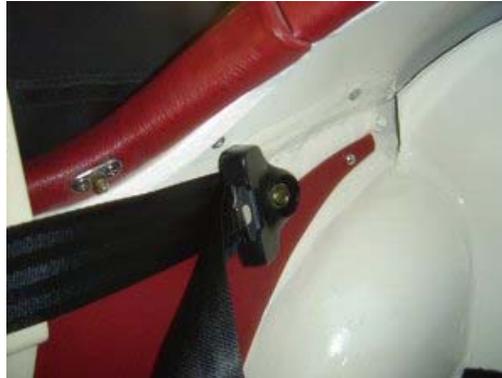
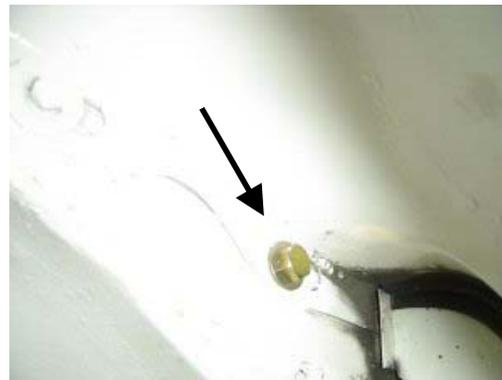
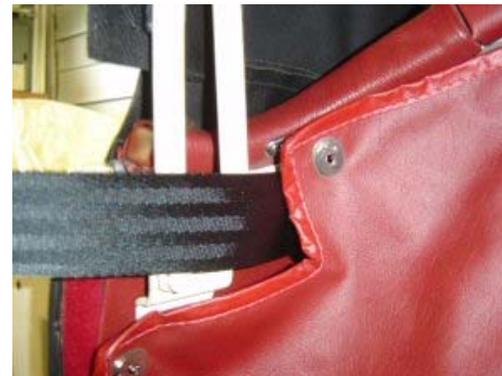
I discovered another option. The second rear fender mounting bolt from the door was in a good position for mounting the belt. The bolts are 5/16" NF, and after looking up the shear strength of a 5/16" grade 5 bolt and some calculations I realized that the standard fender bolts (in a longer length) would not be strong enough. The 7/16" grade 5 bolts that were supplied with the 3 point kit had plenty of shear strength safety factor. I decided to drill out the second bolt hole on each side to 7/16" diameter to accept the bolts in the Moss kit. This opens the hole in the spot welded nut and through the inner fender panel.

After painting the drilled area, I then passed the 7/16" bolt with a heavy support washer under the head through the hole from the fender side, and placed the spacer and belt mount over the bolt. After applying some blue Loctite to the end of the bolt, I installed the nut and tightened the assembly. The result I believe, is a neat and very strong installation. When the side curtain pouch is in position, the belt passes through the vertical gap next to the side panel. When the convertible top is lowered it is necessary to unclip the belt, pass it over the folded top frame and clip it back on. If at some time it was desired to return the setup to the original 5/16" NF bolt size you could make 5/16" NF threaded inserts from a length of a 1/2" NC bolt, thread the holes in the body 1/2" NC also and screw the inserts in place with red Loctite.
