# BUYING AN MG MIDGET

By Richard Ladds

Reprinted, with permission, from *Enjoying MG*, October 1997

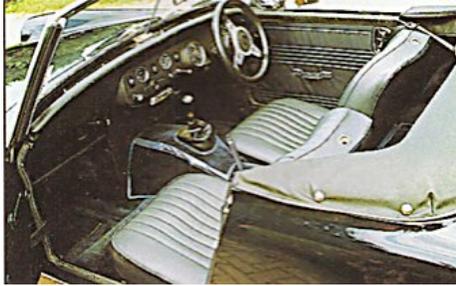
Wear on the carpets and seat coverings is not uncommon but there is a wide choice of replacement trim panels available. It is possible to upgrade the specification of carpet and seat covering, leather faced covers are a popular choice for the later models. The car featured has excellent dark blue leather seats which are both comfortable and attractive.
