My MGB Finally Gives-up Smoking at the age of 42

by Rick Astley with a lot of help from Harry Mac Lean

Quitting Smoking can be Hard

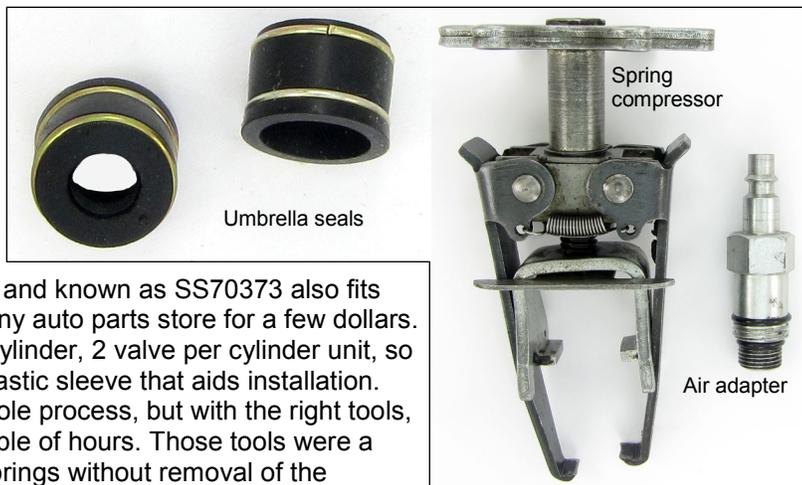
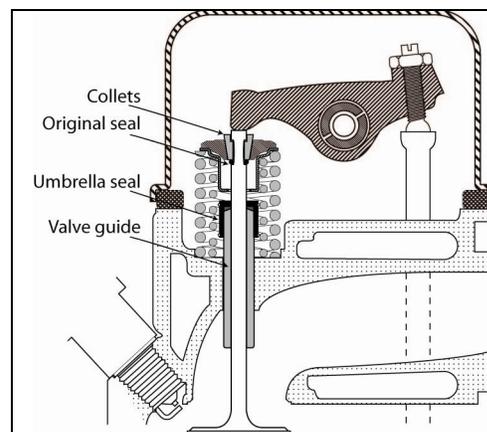
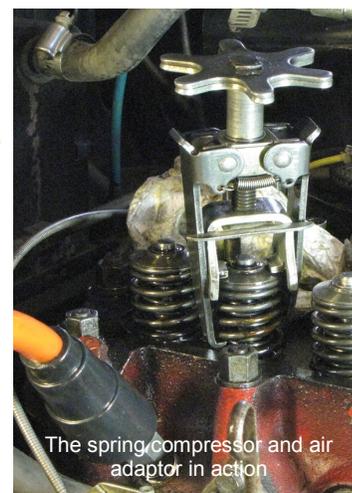
The drawing at right shows how the umbrella seal fits over the valve guide and stops oil from going down the valve stem and entering the cylinder. It also shows the original seals, which don't seem well positioned to do very much at all. In order to fit the new seals, the rocker arm assembly has to be removed, the valve spring compressed and the collets withdrawn, all of which then allows the springs to be removed and the valve guides to be accessed.

I'm no mechanic, so won't try to describe the whole process, but with the right tools, even I was able to install the umbrella seals in a couple of hours. Those tools were a special spring compressor that can grab the valve springs without removal of the cylinder head, an air-compressor and an adaptor that allows the application of compressed air to the cylinder via the spark plug holes and which prevents the valves falling into the cylinder. I was able to borrow the spring-compressor, already have the air-compressor and I found I had the adaptor in a cylinder compression test kit I'd owned some time and often wondered what it was for.

If you're considering doing this job, there are a few things I learned that are worth passing on. The piece of kitchen towel behind the spring compressor in the picture wasn't there by accident. The collets have a mind of their own when they are released and paper or rag helps prevent them from falling down the valve push-rod holes. Reinstalling the collets can be frustrating, and to save work, you may wish to only fit the new seals to the inlet valves that do all the sucking, oil leakage through the exhaust valve guides being much less severe. Take Harry's advice and remove the original seals because once the umbrella seals are in place the almost ineffectual old seals become totally useless and refitting the collets without them is much easier. Be prepared to have to use a little muscle to compress the inner valve spring since the compressor only grabs the stronger outer one. Don't take any notice of anyone who says that the new seals will starve the valve guides of oil; as Harry points out, these are not very sophisticated seals and leak just sufficient oil to do the job. Lastly, you'll be working from the right side of the engine bay and although I used a broomstick to prop the bonnet up, my head found the sharp cornered bonnet-stay bracket on a couple of occasions and I wished I'd taken the time to either tape a pad over it or wear a hat, so making the job that much less bloody.

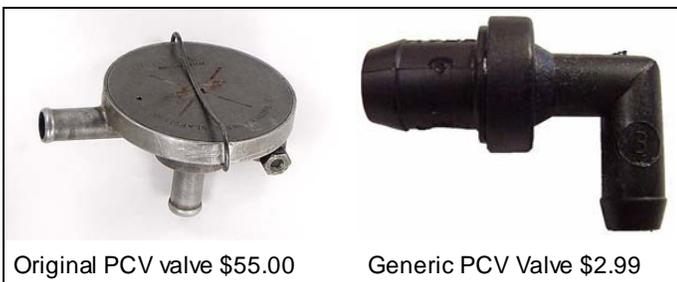
I found tuning to be almost impossible and decided there was an air leak somewhere. Strategically squirting carburetor cleaner around the inlet manifold area usually reveals the source of a leak when the idle speed increases a little, but I found no leak that way. Then my attention was drawn to the PCV (Positive Crankcase Ventilation) valve, part of the system that allows gases to escape in a controlled manner from the crankcase and return them to the engine rather than pollute the atmosphere. This is necessary because internal combustion inevitably involves a small but continual amount of blow-by, which occurs when some of the gases from the combustion leak past the piston rings. The PCV valve provides that control by doing a delicate dance between letting just enough gas return to the inlet manifold without allowing so much as to upset the fuel/air mixture to any significant extent. Sealing off the inlet manifold from the PCV valve and letting the engine vent to air improved things no end.

Inspecting the PCV valve showed its diaphragm to have a split in it, so, rather than continue venting engine gases to the environment I replaced that for about \$5.

Unfortunately, while it somewhat improved the smoke problem, there was definitely still an air leak, and I decided that there were probably worn springs and seals in the inaccessible parts of the original valve. What did bring things back to normal, however, allowing me to tune the engine better than it's been for years, was changing

the original PCV valve for a \$2.99 generic type from Pep Boys.
