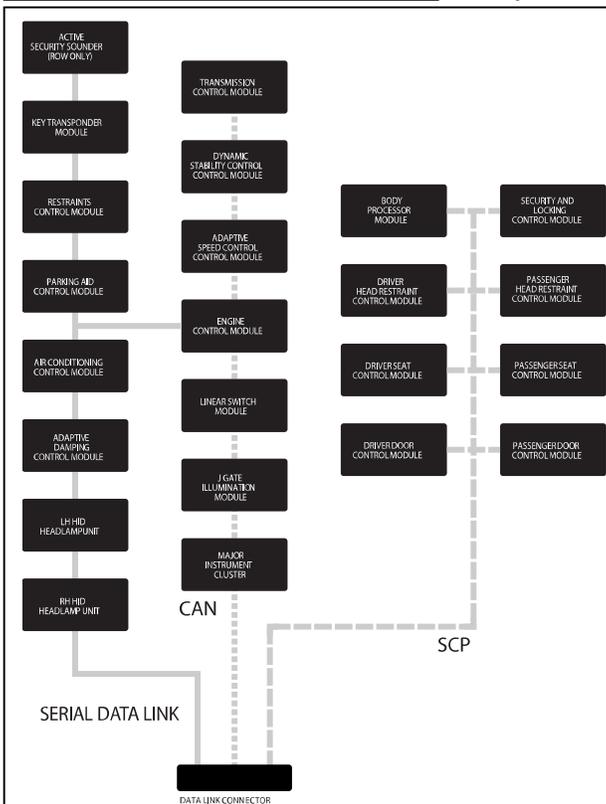
Even my 18 year old Jaguar has 23 boxes interconnected by 3 different data protocols, far fewer than on more recent vehicles.
